# Weeps Why, Where and When

By John H. Koester

The MTI article “Weep Now or Weep Later” addressed the function (or in many cases the “dysfunction”) of various types of weep materials and devices. This article addresses the “why, where and when” of weeping masonry walls.

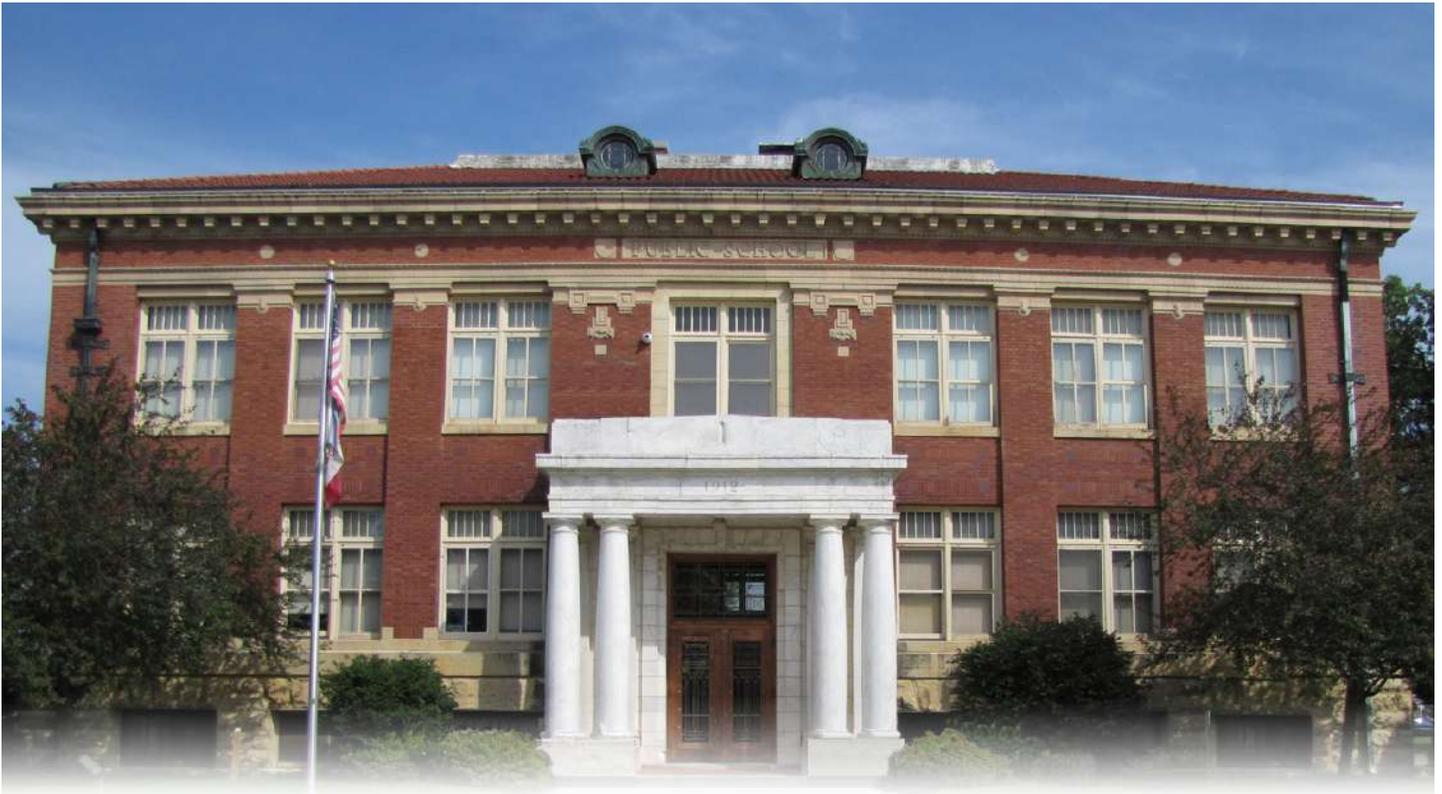
The sample building has numerous identified moisture management “risk zones” on and in its exterior building envelope.

What constitutes a moisture management "risk zone?" It is a section of the exterior building envelope that has a specific, unique exposure to moisture. (see Sample Building) The moisture management risk can vary in intensity from very low to extremely high. One of the main reasons for identifying the various "risk zones," and the degree of moisture management risk they represent, is to design the appropriate risk management detail. A second reason for this process is to understand and outline the boundaries of the risk zones to design details in a way that separates them from one another.

Risk Zone #1 is an example of a parapet wall “risk zone” (See Sample Building and Detail 1A) with multiple associated moisture management details.

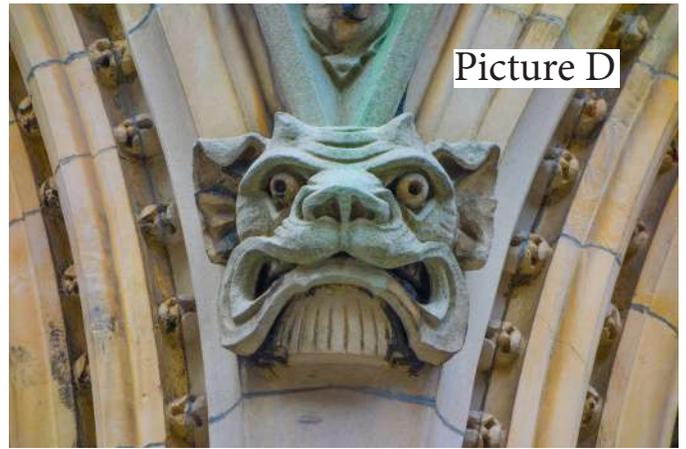
Like many good practices and details in the construction industry, the moisture management detailing for arches has been lost to history. Arches have been in common use since the time of the Romans, and so has the moisture management detailing required to preserve them; however, most people today simply pass it off as decoration. The gaping mouths in the heads of animals and gargoyles that serve as column caps supporting arches on ancient and medieval structures are actually the weep exits (holes) for the arches' moisture management system. (See Picture D)
