FOR BOTTOM OF WALL
FENCE DETAIL VIEW
DETAIL 03FB02BW001

**FULL BRICK VENEER WALL FENCE
COPING STONE POURED IN PLACE**

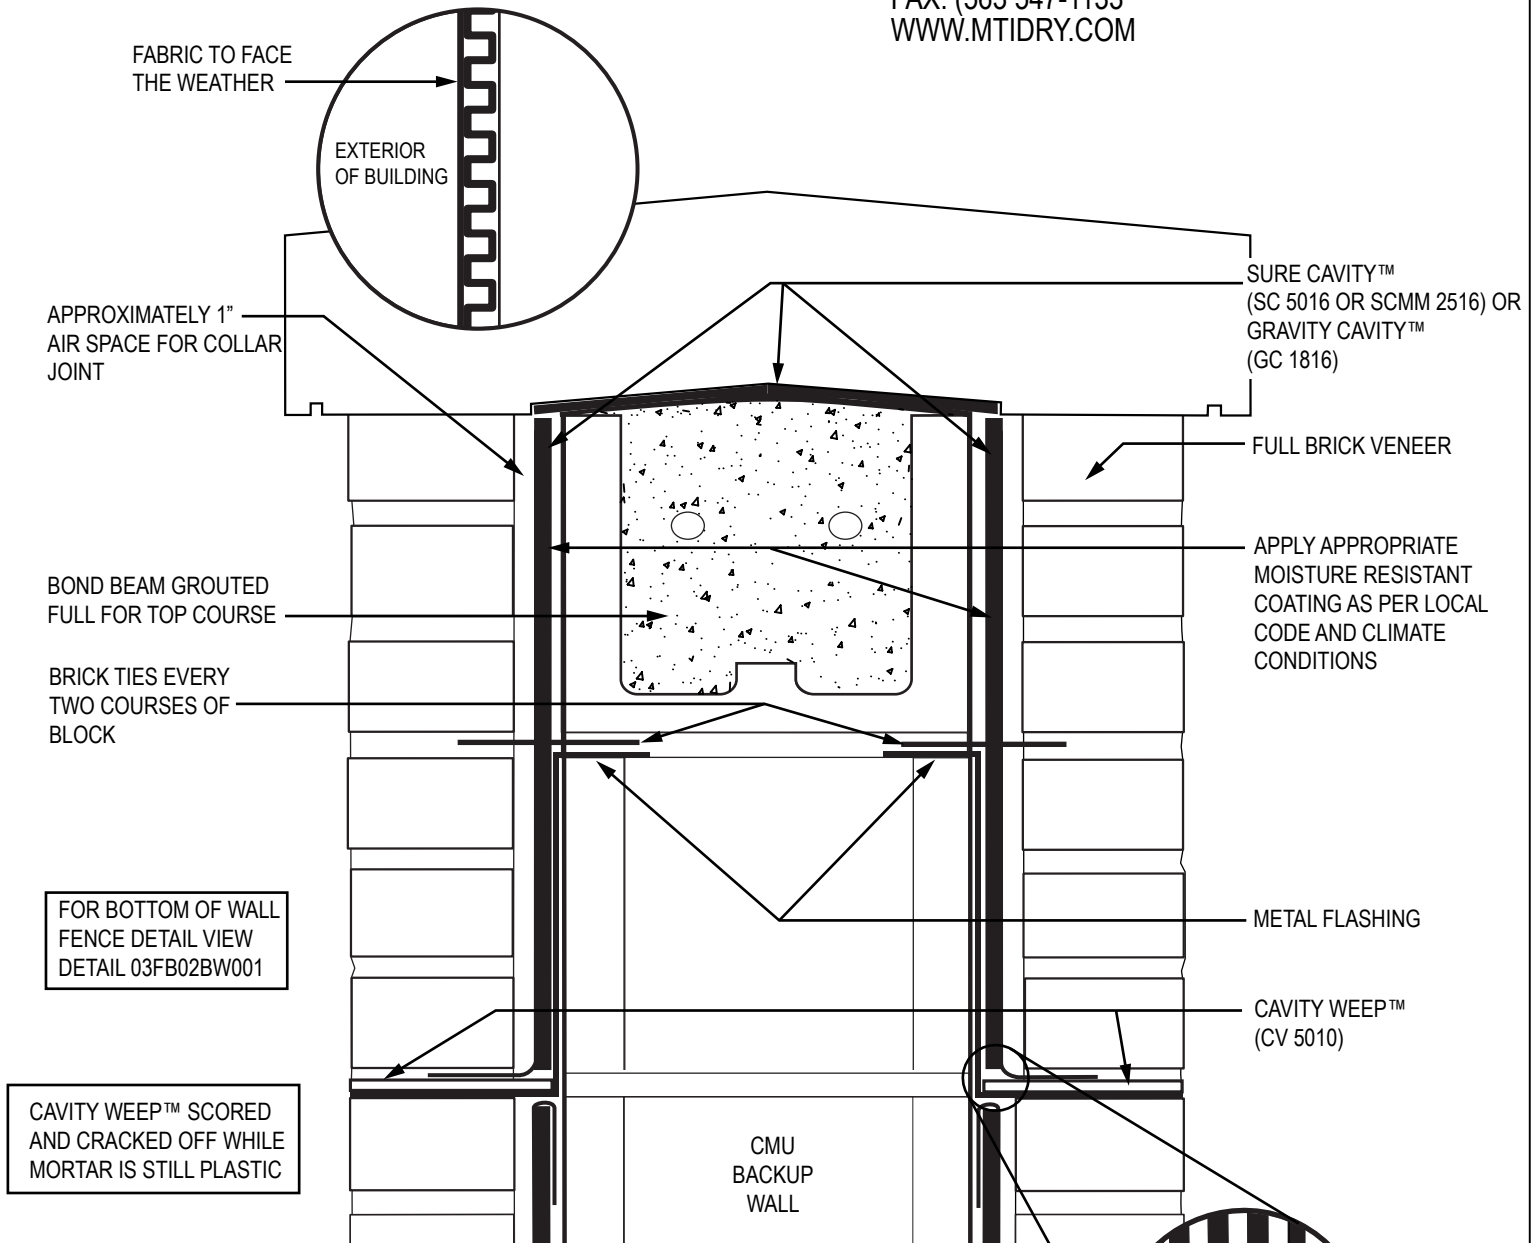
CAVITY WEEP™ SCORED
AND CRACKED OFF WHILE
MORTAR IS STILL PLASTIC

SURE CAVITY™ (SC 5016) OR 10MM SURE CAVITY™ (SCMM 2516) OR
GRAVITY CAVITY™ (GC 1816) AND CAVITY WEEP™ (CV 5010)

TRIM SKIRT TO
OVERLAP WEEPS
